**Flood Control Project Maintenance
Levee Inspections**
LMA District Cover Sheet
Spring 2017 Levee Inspection Results

Reclamation District No. 0150 Merrit Island

Spring 2017 Levee Inspection Results

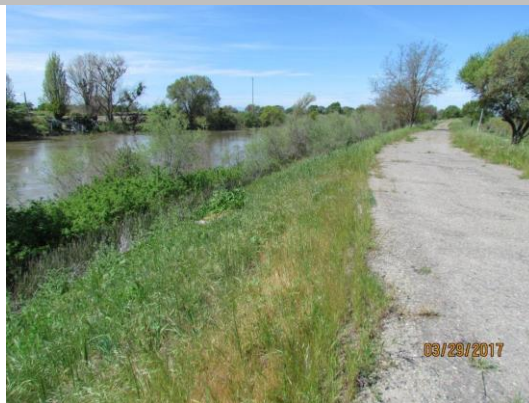
Photo 1 of 1 : SP_2017_RD0150_15_1_20170405_00005.jpg

LM Start	0.02	Rating **	M	Issue No.	1
LM End	0.50	Issue Type +	Ma	Location *	WS
Category	Earthen Levee			GPS Latitude/Longitude	
				Start	End
Item	Vegetation			38.332523 °	38.328236 °
				-121.583140 °	-121.576547 °
DWR ID	DWR_RD0150_01_s_2017_1				
Comment Code					
V1 : Control annual grass and weeds on the levee slopes and easements.					
Inspector Comment

View of vegetation on the waterside slope of the levee.

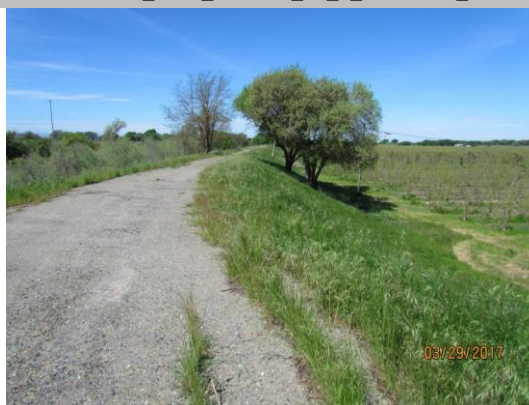
Photo 1 of 1 : SP_2017_RD0150_15_8_20170405_00006.jpg

LM Start	0.02	Rating **	M	Issue No.	8
LM End	0.50	Issue Type +	Ma	Location *	LS
Category	Earthen Levee			GPS Latitude/Longitude	
				Start	End
Item	Vegetation			38.332520 °	38.328236 °
				-121.583139 °	-121.576547 °
DWR ID	DWR_RD0150_01_s_2017_8				
Comment Code					
V1 : Control annual grass and weeds on the levee slopes and easements.					
Inspector Comment

View of vegetation on the landside slope of the levee.

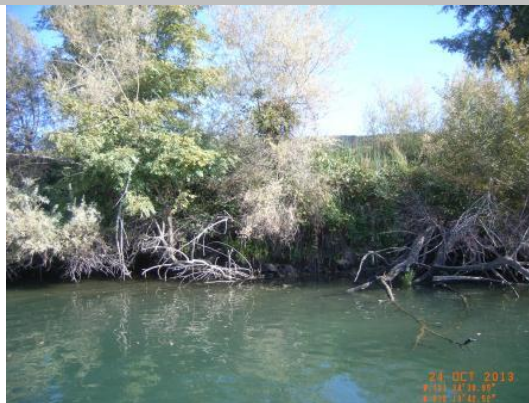
Photo 1 of 2 : SP_2017_RD0150_15_2_20170327_00001.jpg

LM Start	0.44	Rating **	M	Issue No.	2
LM End	0.49	Issue Type +	Ma	Location *	WS
Category	Supplemental			GPS Latitude/Longitude	
				Start	End
Item	2015 USACE Erosion Survey, DRAFT			38.328555 °	38.328020 °
				-121.577544 °	-121.576693 °
DWR ID	DWR_RD0150_01_s_2016_2				
Comment Code					
Inspector Comment					
2013 - Old toe repair unraveling. Bridge at upstream end of site. 2015: No observed changes. [2015 Site ID: STR_28-4_R]

USACE 2013 Photo #1

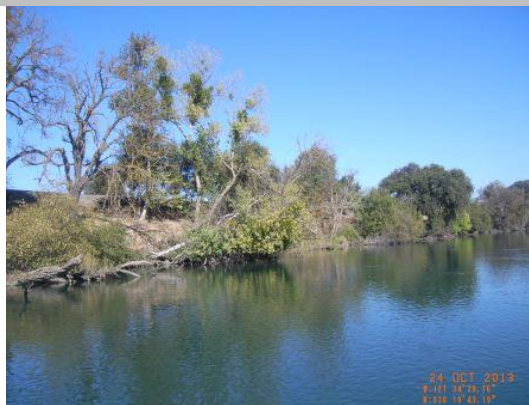
Photo 2 of 2 : SP_2017_RD0150_15_2_20170327_00002.jpg

LM Start	0.44	Rating **	M	Issue No.	2 (cont)
LM End	0.49	Issue Type +	Ma	Location *	WS

USACE 2013 Photo #2

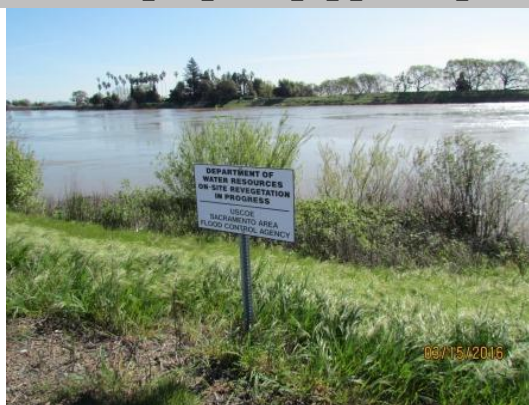
Photo 1 of 1 : SP_2017_RD0150_16_5_20170327_00002.jpg

LM Start	0.14	Rating **	A/W	Issue No.	5
LM End	4.77	Issue Type +	Ob	Location *	WS
Category	Earthen Levee			GPS Latitude/Longitude	
				Start	End
Item	Vegetation			38.329782 °	38.374641 °
				-121.574769 °	-121.524730 °
DWR ID	DWR_RD0150_02_s_2012_5				
Comment Code					
V8 : Environmental Requirements.					
Inspector Comment

View of the re-vegetation sign.

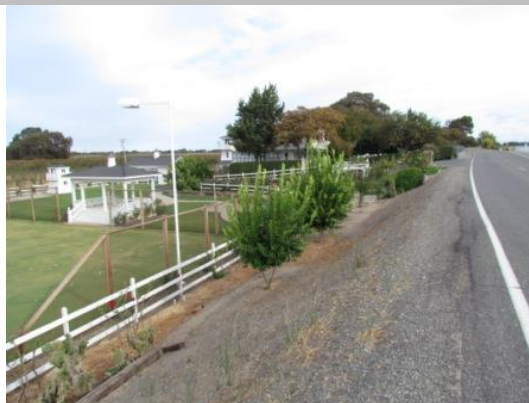
Photo 1 of 1 : SP_2017_RD0150_16_990_20170327_00058.jpg

LM Start	0.17	Rating **	M	Issue No.	990
LM End	0.21	Issue Type +	En	Location *	LS
Category	Earthen Levee			GPS Latitude/Longitude	
				Start	End
Item	Vegetation			38.330173 °	38.330576 °
				-121.574490 °	-121.574093 °
DWR ID	DWR_RD0150_02_s_2012_990				
Comment Code					
V6 : Landscaping					
Inspector Comment

Landscaping was found on the landside of the levee looking upstream.

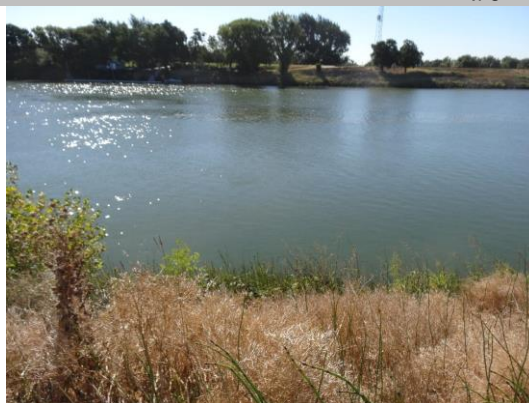
Photo 1 of 3 : UCIP_SP_2017_42700_34247.jpg

LM Start	0.23	Rating **	M	Issue No.	991
LM End	0.23	Issue Type +	En	Location *	LS
Category	Supplemental			GPS Latitude/Longitude	
				Start	End
Item	DWR UCIP Field Study			38.330888 °	38.330888 °
				-121.573769 °	-121.573769 °
DWR ID					
Comment Code					
Inspector Comment					
FS_ID:42700 DS_ID:22416 EP_NO: N/A Repair Type: Non-Urgent Crossing Status: Found UCIP Comments: Appears abandoned and if so should be done so properly.- Dense vegetation on waterside.- Seems abandoned pipe and pump. FIELD_STRUCT_DESC: Abandoned 10-inch steel pipe through the levee, 2.8 feet below the crown. Pump on landside. Concrete box on landside. O&M Manual SAC 112, March 1957. FS Date: 8/27/2013

WS view: No pipe found on waterside slope. Dense vegetation on waterside.

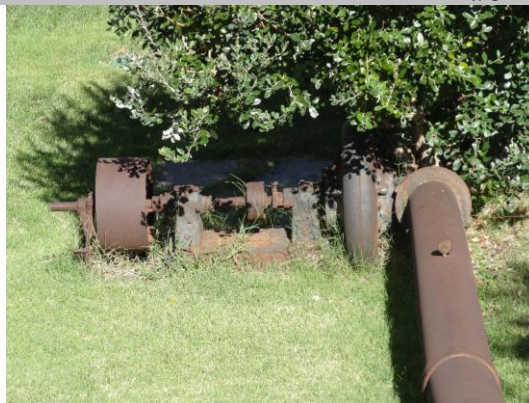
Photo 2 of 3 : UCIP_SP_2017_42700_34246.jpg

LS view: abandoned pipe and pump on landside toe.

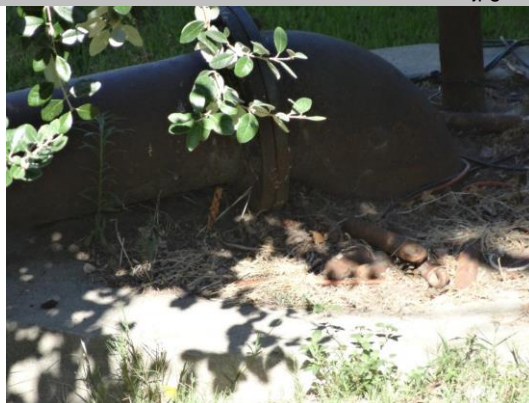
Photo 3 of 3 : UCIP_SP_2017_42700_34245.jpg

LS view: abandoned pipe and concrete box on landside toe.

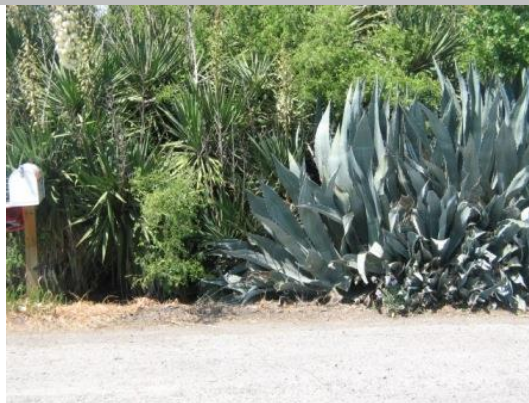
Photo 1 of 1 : SP_2017_RD0150_16_4_20170327_00001.jpg

LM Start	0.25	Rating **	U	Issue No.	4
LM End	0.25	Issue Type +	En	Location *	LS
Category	Earthen Levee			GPS Latitude/Longitude	
				Start	End
Item	Vegetation			38.331035 °	38.331035 °
				-121.573502 °	-121.573502 °
DWR ID	DWR_RD0150_02_s_2012_4				
Comment Code					
V6 : Landscaping					
Inspector Comment

Landscaping on landward slope of the levee.

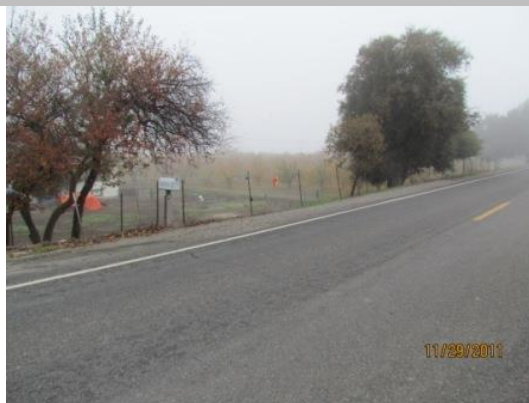
Photo 1 of 1 : SP_2017_RD0150_16_9_20170327_00006.jpg

LM Start	0.34	Rating **	M	Issue No.	9
LM End	0.34	Issue Type +	En	Location *	LS
Category	Earthen Levee			GPS Latitude/Longitude	
				Start	End
Item	Encroachments			38.332156 °	38.332156 °
				-121.572580 °	-121.572580 °
DWR ID	DWR_RD0150_02_s_2012_9				
Comment Code					
FE : Fence					
Inspector Comment

Fence was found on the landside of the levee looking upstream.

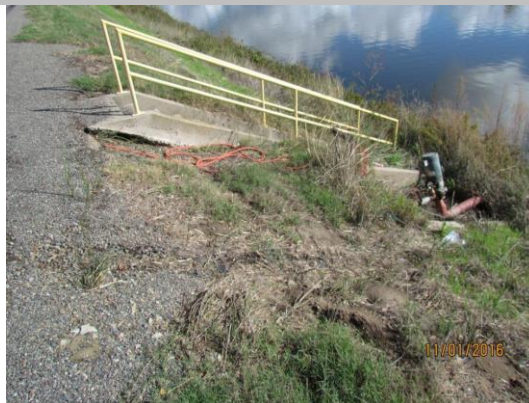
Photo 1 of 2 : SP_2017_RD0150_16_6_20170327_00003.jpg

LM Start	0.38	Rating **	M	Issue No.	6
LM End	0.38	Issue Type +	Ma	Location *	WS
Category	Earthen Levee			GPS Latitude/Longitude	
				Start	End
Item	Slope Stability			38.332598 °	38.332598 °
				-121.572179 °	-121.572179 °
DWR ID	DWR_RD0150_02_s_2012_6				
Comment Code					
S2 : Repair the levee slope damaged by foot traffic and prevent access where possible.					
Inspector Comment

Updated view of the slope instability on the waterside of the levee. Fall 2016

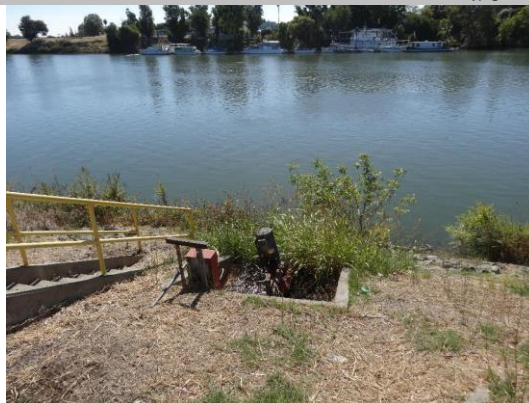
Photo 1 of 3 : UCIP_SP_2017_20268_34244.jpg

FS_ID:20268
DS_ID:22417
EP_NO: N/A
Repair Type: Non-Urgent
Crossing Status: Found
UCIP Comments: - Water leaks from pressure breaker.- Distribution box at the landward toe not found/visible.- Service pole on LS toe.
FIELD_STRUCT_DESC: 4-inch steel pipe joined to 6-inch steel pipe and the 6-inch pipe joined to 10-inch steel pipe through the levee, 5.8 feet below the crown. 1.5-inch conduit through the levee, 3 feet below the crown. Pump and gate valve on the waterward slope. (Runyon).
FS Date: 8/27/2013

WS view: walkway/stairs, pump on levee slope.

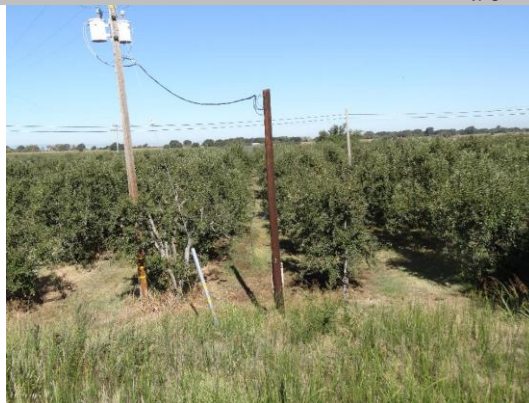
Photo 3 of 3 : UCIP_SP_2017_20268_34242.jpg

LM Start	0.39	Rating **	M	Issue No.	992 (cont)	
LM End	0.39	Issue Type +	En	Location *	WS	
Category	Supplemental			GPS Latitude/Longitude		
				Start	End	
Item	DWR UCIP Field Study			38.332670 °	38.332670 °	
				-121.572132 °	-121.572132 °	
DWR ID						
Comment Code						
Inspector Comment						
FS_ID:20268						
DS_ID:22417						
EP_NO: N/A						
Repair Type: Non-Urgent						
Crossing Status: Found						
UCIP Comments: - Water leaks from pressure breaker.- Distribution box at the landward toe not found/visible.- Service pole on LS toe.						
FIELD_STRUCT_DESC: 4-inch steel pipe joined to 6-inch steel pipe and the 6-inch ppipe joined to 10-inch steel pipe through the levee, 5.8 feet below the crown. 1.5-inch conduit through the levee, 3 feet below the crown. Pump and gate valve on the waterward slope. (Runyon).						
FS Date: 8/27/2013

LS view: distribution box not found/visible on levee toe.

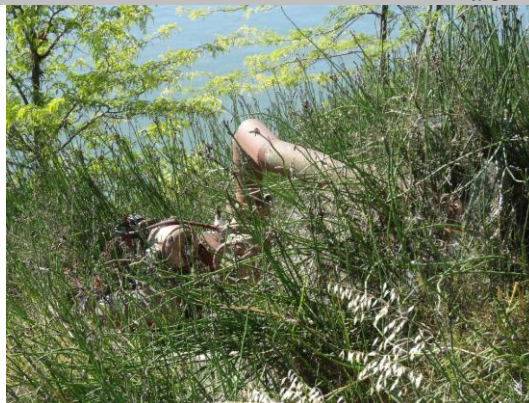
Photo 1 of 3 : UCIP_SP_2017_20267_34239.jpg

LM Start	0.46	Rating **	M	Issue No.	993
LM End	0.46	Issue Type +	En	Location *	WS
Category	Supplemental			GPS Latitude/Longitude	
				Start	End
Item	DWR UCIP Field Study			38.333527 °	38.333527 °
				-121.571274 °	-121.571274 °
DWR ID					
Comment Code					
Inspector Comment					
FS_ID:20267					
DS_ID:22418					
EP_NO: N/A					
Repair Type: Non-Urgent					
Crossing Status: Found					
UCIP Comments: - Abandoned pipe and pump.- Needs proper abandonment.					
FIELD_STRUCT_DESC: 6-inch steel pipe and 1-inch conduit through the levee, 3.5 feet below crown, pump and gate valve on the waterward slope. Electric box on waterside slope. O&M Manual SAC 112, March 1957.					
FS Date: 8/27/2013

WS view: steel pipe and pump on levee slope. Dense vegetation on waterside.

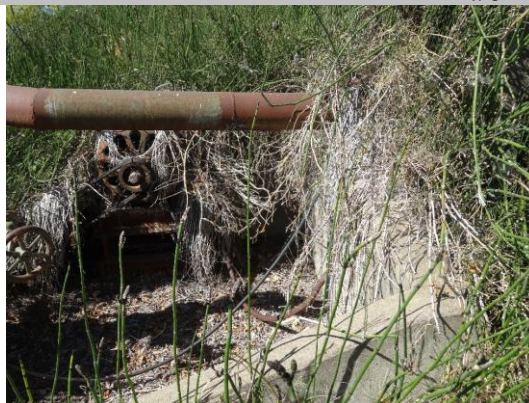
Photo 2 of 3 : UCIP_SP_2017_20267_34238.jpg

WS view: steel pipe and pump on concrete pad. Seems abandoned.

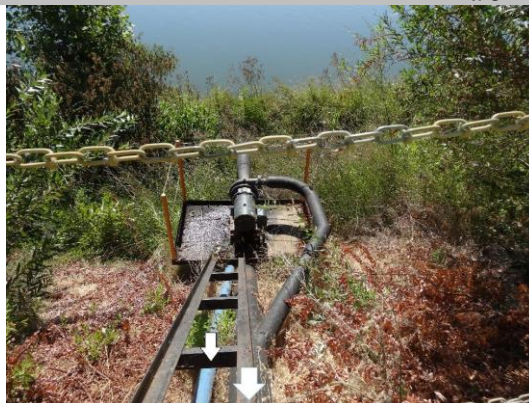
Photo 1 of 3 : UCIP_SP_2017_20303_34287.jpg

Comment Code					
Inspector Comment					
FS_ID:20303 DS_ID:22421 EP_NO: 16109 Repair Type: Non-Urgent Crossing Status: Found UCIP Comments: - 10" steel pipe on both sides of the levee. According to permit and inspectors note- 16" steel pipe through the levee.- concrete standpipe inside water filtration plant on landside toe.- air pressure tank on waterside steel deck. FIELD_STRUCT_DESC: 16 inch steel pipe and 2-inch conduit through the levee, 6.2 feet below the crown, slant pump on steel platform on the waterward slope. 4-inch abandoned pipe on the waterside slope. Concrete stand pipe and power pole at landside toe. (App. No. 18258, Wilson 2007) O&M Manual SAC 112, March 1957. FS Date: 8/27/2013

WS view: slant pump on steel deck, 4-inch pipe (left) and 10-inch pipe (right) on levee slope.

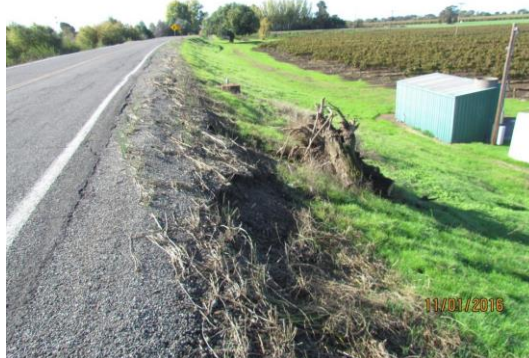
Photo 1 of 2 : SP_2017_RD0150_16_59_20170327_00032.jpg

LM Start	0.71	Rating **	M	Issue No.	59
LM End	0.71	Issue Type +	Ma	Location *	LS
Category	Earthen Levee			GPS Latitude/Longitude	
				Start	End
Item	Encroachments			38.336291 °	38.336291 °
				-121.568260 °	-121.568260 °
DWR ID	DWR_RD0150_02_s_2016_59				
Comment Code					
TR : Tree or limb					
Inspector Comment					
Damaged tree roots and trunks appear to damage landside slope of the levee.

Updated picture of the tree limbs and roots on the landside of the levee looking downstream. Fall 2016

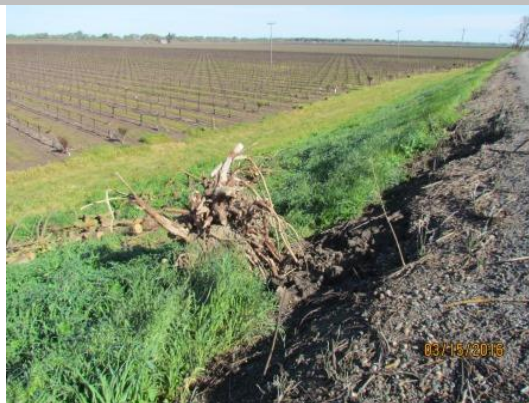
Photo 2 of 2 : SP_2017_RD0150_16_59_20170327_00033.jpg

View of tree trunks and roots on the landside of the levee looking upstream.

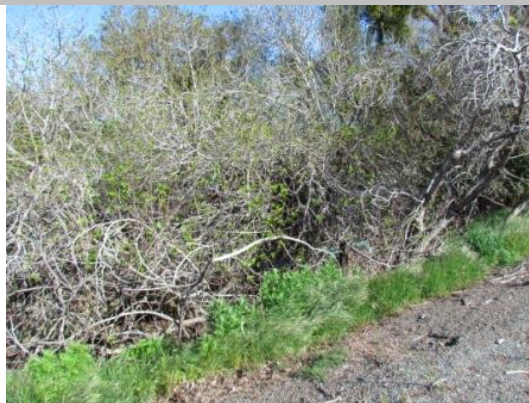
Photo 1 of 1 : SP_2017_RD0150_16_12_20170327_00008.jpg

LM Start	0.97	Rating **	M	Issue No.	12
LM End	0.97	Issue Type +	En	Location *	LS
Category	Earthen Levee			GPS Latitude/Longitude	
				Start	End
Item	Encroachments			38.339035 °	38.339035 °
				-121.565145 °	-121.565145 °
DWR ID	DWR_RD0150_02_s_2012_12				
Comment Code					
TR : Tree or limb					
Inspector Comment

Overgrown trees were obstructing the landside slope of the levee looking upstream.

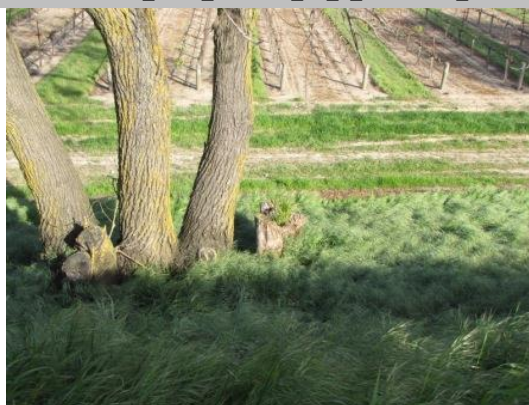
Photo 1 of 1 : SP_2017_RD0150_16_8_20170327_00005.jpg

LM Start	1.14	Rating **	N	Issue No.	8
LM End	1.14	Issue Type +	Ma	Location *	LS
Category	Earthen Levee			GPS Latitude/Longitude	
				Start	End
Item	Trim / Thin Trees			38.340864 °	38.340864 °
				-121.562915 °	-121.562915 °
DWR ID	DWR_RD0150_02_s_2012_8				
Comment Code					
T5 : Tree stumps.					
Inspector Comment

View of a tree stump on the landward slope.

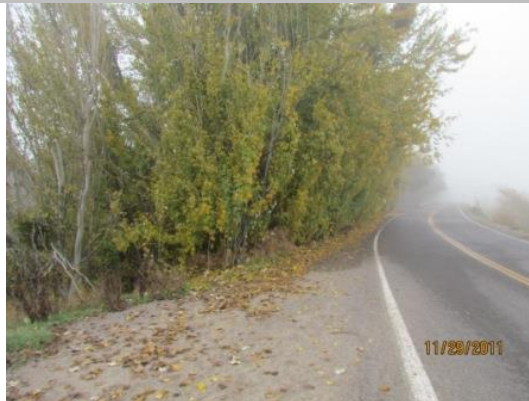
Photo 2 of 2 : SP_2017_RD0150_16_91_20170327_00049.jpg

LM Start	1.32	Rating **	U	Issue No.	91 (cont)
LM End	1.34	Issue Type +	En	Location *	LS

Landscaping was found landside of the levee looking upstream.

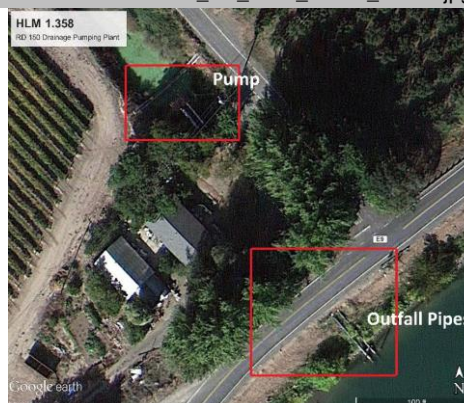
Photo 1 of 3 : UCIP_SP_2017_20727_34889.jpg

FS_ID:20727
DS_ID:22393
EP_NO: 18221
Repair Type: Non-Urgent
Crossing Status: Found
UCIP Comments: Pump house and drainage ditch about 250 feet from the levee on landside. Pumps on piling structure with shed in drainage ditch. Siphon breaker cover missing. Needs to fix it.
FIELD_STRUCT_DESC: 1 of 2: 30-inch pipe (of 30-inch and 24-inch steel pipes), 7.0 feet below the crown replaced 36-inch and 24-inch pipes through the levee, 9.0 and 8.0 feet below the crown respectively. Flap gates on the waterward ends. Siphon breakers on the waterward slope. Pumps on piling structure with shed in drainage ditch. (App. No. 18221 - R.D. No. 150 drainage plant). O&M Manual SAC 112, March 1957.
FS Date: 8/27/2013

LM Start	1.34	Rating **	M	Issue No.	996 (cont)
LM End	1.34	Issue Type +	Ma	Location *	LS

Bird's eye view: outfall pipes (bottom) and pump structure in drainage ditch (top)

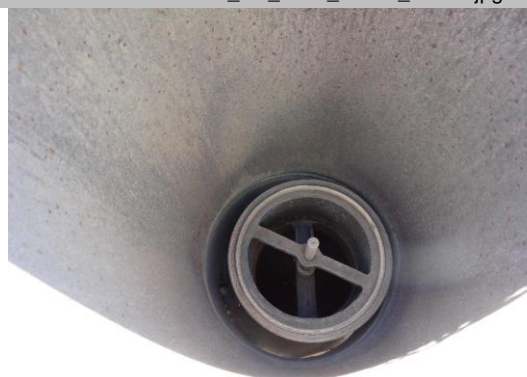
Photo 2 of 3 : UCIP_SP_2017_20727_34888.jpg

WS view: siphon breaker in pipe riser on levee shoulder.

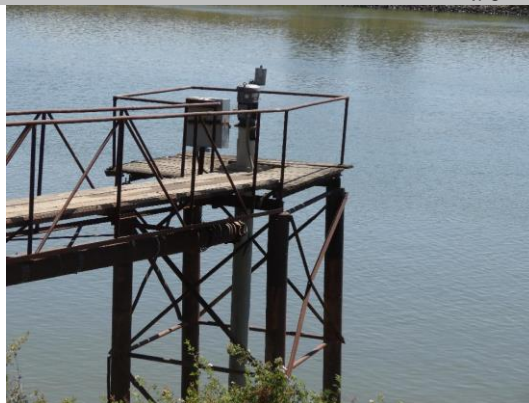
Photo 2 of 3 : UCIP_SP_2017_20348_34370.jpg

FS_ID:20348
DS_ID:22395
EP_NO: N/A
Repair Type: Non-Urgent
Crossing Status: Found
UCIP Comments: - Operating during inspection.- Overhead powerline crossing- CMP riser with siphon breaker needs cleaning.
FIELD_STRUCT_DESC: 12-inch steel pipe through the levee, 4.0 feet below the crown; pump on the piling in the stream. Power poles on both slopes. Ramp on the landward slope. Siphon breaker on the landward shoulder. (T. Wilson). O&M Manual SAC 112, March 1957.
FS Date: 8/27/2013

LM Start	1.91	Rating **	M	Issue No.	998 (cont)
LM End	1.91	Issue Type +	En	Location *	WS

WS view: pipe & pump on piling structure in the stream.

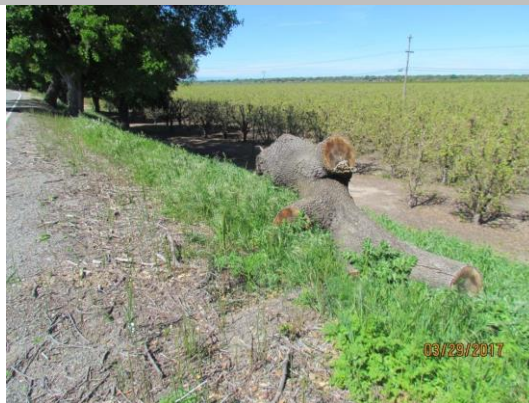
Photo 1 of 1 : SP_2017_RD0150_16_63_20170405_00121.jpg

LM Start	2.10	Rating **	M	Issue No.	63
LM End	2.10	Issue Type +	Ma	Location *	LS
Category	Earthen Levee			GPS Latitude/Longitude	
				Start	End
Item	Encroachments			38.347002 °	38.347002 °
				-121.547803 °	-121.547803 °
DWR ID	DWR_RD0150_02_f_2016_63				
Comment Code					
TR : Tree or limb					
Inspector Comment

View of a tree trunk on the landside slope of the levee.

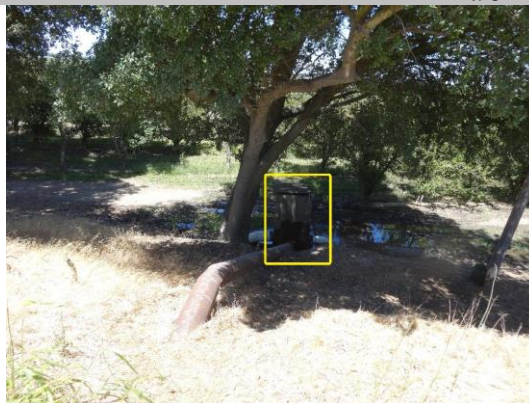
Photo 2 of 3 : UCIP_SP_2017_20731_34901.jpg

LM Start	2.14	Rating **	M	Issue No.	999 (cont)	
LM End	2.14	Issue Type +	En	Location *	LS	
Category	Supplemental			GPS Latitude/Longitude		
				Start	End	
Item	DWR UCIP Field Study			38.347032 °	38.347032 °	
				-121.547159 °	-121.547159 °	
DWR ID						
Comment Code						
Inspector Comment						
FS_ID:20731						
DS_ID:22396						
EP_NO: N/A						
Repair Type: Non-Urgent						
Crossing Status: Found						
UCIP Comments: - Operating during inspection. Leaky join at the concrete box.- Power overhead crossing. Power pole at waterside shoulder, and landside toe.						
FIELD_STRUCT_DESC: 12-inch steel pipe through the levee, 5.0 feet below the crown, slant pump on the waterward slope. Power pole on the waterward shoulder. (Wilcox) O&M Manual SAC 112, March 1957.						
FS Date: 8/27/2013

LM Start	2.14	Rating **	M	Issue No.	999 (cont)
LM End	2.14	Issue Type +	En	Location *	LS

LS view: concrete distribution box on levee toe and exposed steel pipe on levee slope.

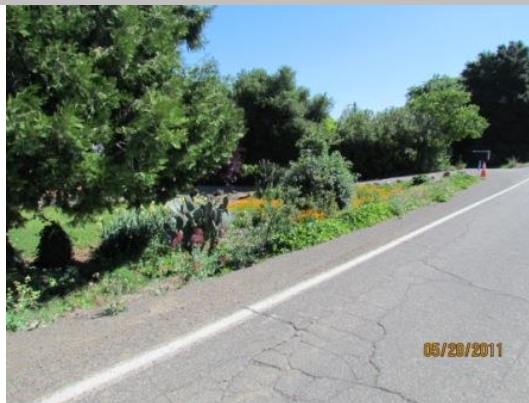
Photo 1 of 1 : SP_2017_RD0150_16_88_20170327_00047.jpg

LM Start	2.28	Rating **	M	Issue No.	88
LM End	2.30	Issue Type +	En	Location *	LS
Category	Earthen Levee			GPS Latitude/Longitude	
				Start	End
Item	Vegetation			38.347355 °	38.347361 °
				-121.544628 °	-121.544280 °
DWR ID	DWR_RD0150_02_s_2012_88				
Comment Code					
V6 : Landscaping					
Inspector Comment

Landscaping was found on the landside of the levee. The picture was taken from the crown looking upstream.

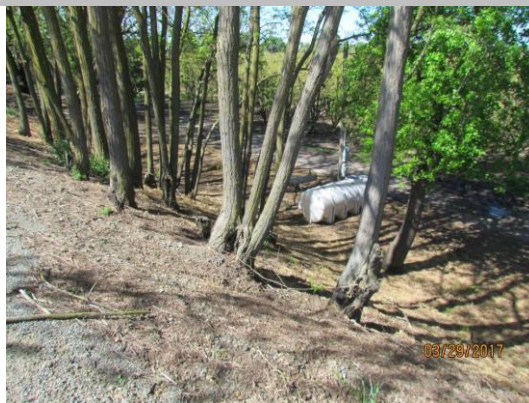
Photo 1 of 1 : SP_2017_RD0150_16_70_20170405_00120.jpg

LM Start	2.72	Rating **	M	Issue No.	70
LM End	2.72	Issue Type +	En	Location *	LS
Category	Earthen Levee			GPS Latitude/Longitude	
				Start	End
Item	Encroachments			38.349777 °	38.349777 °
				-121.537247 °	-121.537247 °
DWR ID	DWR_RD0150_02_s_2017_70				
Comment Code					
TA : Tank					
Inspector Comment

A tank was found on the landside toe of the levee.

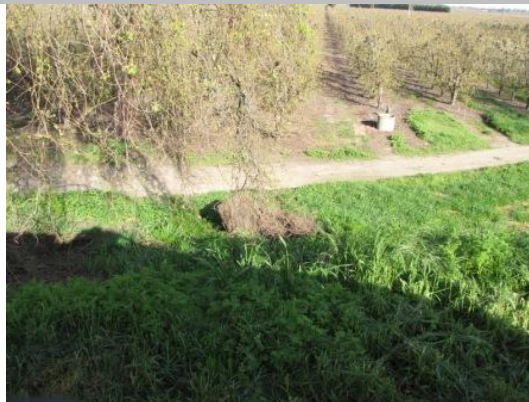
Photo 1 of 1 : SP_2017_RD0150_16_14_20170327_00010.jpg

LM Start	2.75	Rating **	N	Issue No.	14
LM End	2.75	Issue Type +	Ma	Location *	LS
Category	Earthen Levee			GPS Latitude/Longitude	
				Start	End
Item	Trim / Thin Trees			38.350041 °	38.350041 °
				-121.536853 °	-121.536853 °
DWR ID	DWR_RD0150_02_s_2012_14				
Comment Code					
T5 : Tree stumps.					
Inspector Comment

View of a tree stump on the landward slope.

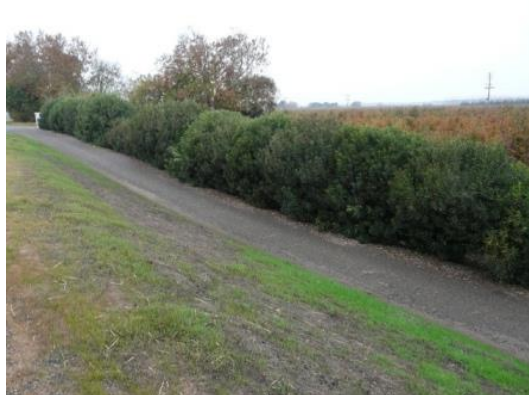
Photo 1 of 1 : SP_2017_RD0150_16_85_20170327_00046.jpg

LM Start	2.97	Rating **	U	Issue No.	85
LM End	3.01	Issue Type +	En	Location *	LS
Category	Earthen Levee			GPS Latitude/Longitude	
				Start	End
Item	Vegetation			38.352372 °	38.352802 °
				-121.534127 °	-121.533638 °
DWR ID	DWR_RD0150_02_s_2012_85				
Comment Code					
V6 : Landscaping					
Inspector Comment

Landscaping providing a screen for a residence on the landside of levee.

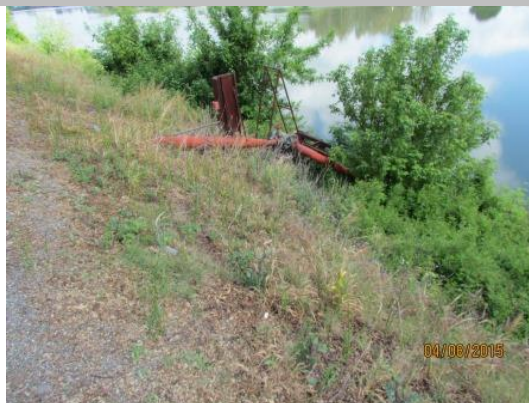
Photo 1 of 5 : SP_2017_RD0150_16_961_20170327_00051.jpg

LM Start	3.24	Rating **	M	Issue No.	961
LM End	3.24	Issue Type +	Ma	Location *	WS
Category	Earthen Levee			GPS Latitude/Longitude	
				Start	End
Item	Erosion / Bank Caving			38.355321 °	38.355321 °
				-121.530902 °	-121.530902 °
DWR ID	DWR_RD0150_02_s_2012_961				
Comment Code					
E2 : Schedule repair of erosion site prior to the next inspection.					
Inspector Comment					
Depressions into the waterward slope can be seen along the waterward slope at this site. Also note the damaged pump support, pump, and pipe just upstream of the site; they may contribute to the erosion in a high water event and should be removed.

Updated picture of the erosion on the waterside of the levee during spring 2015 inspection.

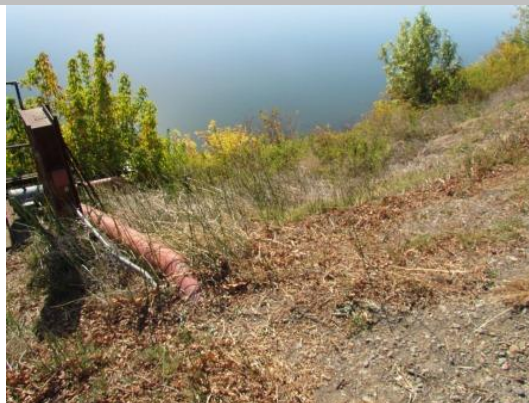
Photo 2 of 5 : SP_2017_RD0150_16_961_20170327_00052.jpg

LM Start	3.24	Rating **	M	Issue No.	961 (cont)
LM End	3.24	Issue Type +	Ma	Location *	WS
Category	Earthen Levee			GPS Latitude/Longitude	
				Start	End
Item	Erosion / Bank Caving			38.355321 °	38.355321 °
				-121.530902 °	-121.530902 °
DWR ID	DWR_RD0150_02_s_2012_961				
Comment Code					
E2 : Schedule repair of erosion site prior to the next inspection.					
Inspector Comment					
Depressions into the waterward slope can be seen along the waterward slope at this site. Also note the damaged pump support, pump, and pipe just upstream of the site; they may contribute to the erosion in a high water event and should be removed.

View of the erosion on the waterside slope of the levee near the pipe looking downstream. This picture was taken during the fall 2013 inspection.

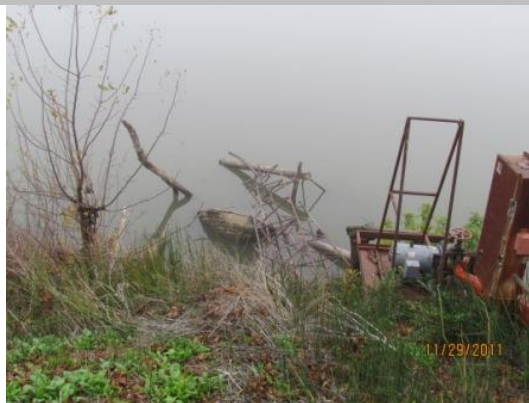
Photo 5 of 5 : SP_2017_RD0150_16_961_20170327_00055.jpg

LM Start	3.24	Rating **	M	Issue No.	961 (cont)
LM End	3.24	Issue Type +	Ma	Location *	WS

View of the erosion site, and broken pump support along with a boat on the waterside of the levee. The picture was taken from the crown looking towards the toe of the levee during fall 2011 inspection.

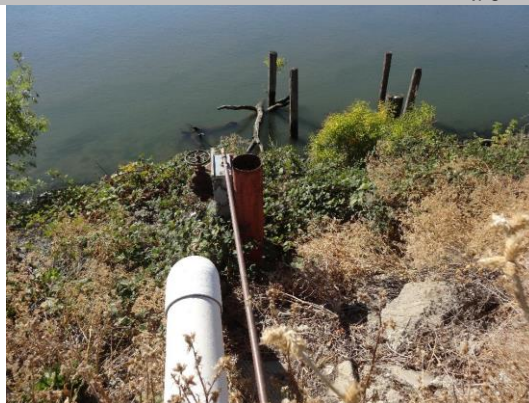
Photo 1 of 3 : UCIP_SP_2017_19846_33727.jpg

LM Start	3.50	Rating **	M	Issue No.	1001
LM End	3.50	Issue Type +	En	Location *	LS
Category	Supplemental			GPS Latitude/Longitude	
				Start	End
Item	DWR UCIP Field Study			38.358094 °	38.358094 °
				-121.527619 °	-121.527619 °
DWR ID					
Comment Code					
Inspector Comment					
FS_ID:19846 DS_ID:22403 EP_NO: N/A Repair Type: Non-Urgent Crossing Status: Found UCIP Comments: - 8" pvc pipe sleeved into 12" steel pipe.- needs filling/grouting in gas between 8" pvc pipe and 12" steel pipe on WS.- 1.5" electric conduit on WS- 10" steel pipe extended to 8" pvc pipe on landside levee toe. FIELD_STRUCT_DESC: 12-inch steel pipe through the levee, 3.0 feet below the crown, pump and gate valve on the waterward slope. (R & J Pylman). O&M Manual SAC 112, March 1957. FS Date: 8/30/2013

LM Start	3.50	Rating **	M	Issue No.	1001 (cont)
LM End	3.50	Issue Type +	En	Location *	LS

WS view: pipe, pump, and conduit on levee slope.

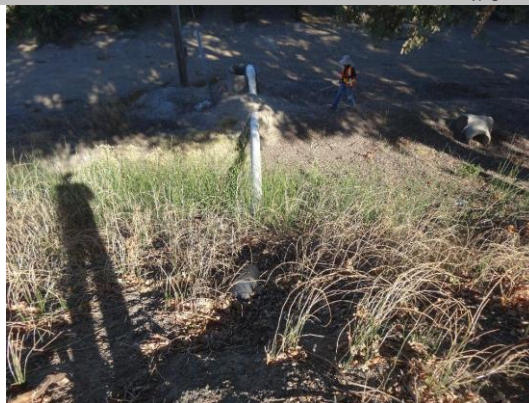
Photo 3 of 3 : UCIP_SP_2017_19846_33725.jpg

LM Start	3.50	Rating **	M	Issue No.	1001 (cont)	
LM End	3.50	Issue Type +	En	Location *	LS	
Category	Supplemental			GPS Latitude/Longitude		
				Start		End
Item	DWR UCIP Field Study			38.358094 °		38.358094 °
				-121.527619 °		-121.527619 °
DWR ID						
Comment Code						
Inspector Comment						
FS_ID:19846 DS_ID:22403 EP_NO: N/A Repair Type: Non-Urgent Crossing Status: Found UCIP Comments: - 8" pvc pipe sleeved into 12" steel pipe.- needs filling/grouting in gas between 8" pvc pipe and 12" steel pipe on WS.- 1.5" electric conduit on WS- 10" steel pipe extended to 8" pvc pipe on landside levee toe. FIELD_STRUCT_DESC: 12-inch steel pipe through the levee, 3.0 feet below the crown, pump and gate valve on the waterward slope. (R & J Pylman). O&M Manual SAC 112, March 1957. FS Date: 8/30/2013

LS view: exposed pipe on levee slope and standpipe on the toe.

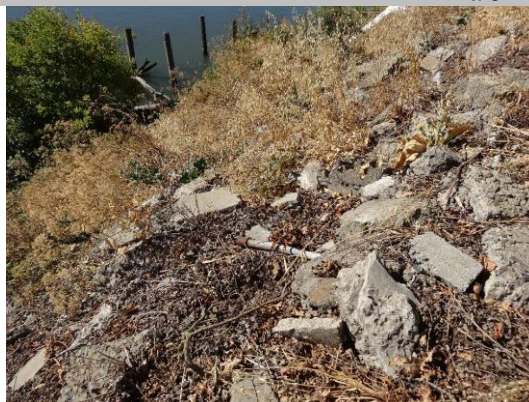
Photo 1 of 3 : UCIP_SP_2017_19848_33734.jpg

LM Start	3.51	Rating **	M	Issue No.	1002
LM End	3.51	Issue Type +	En	Location *	LS
Category	Supplemental			GPS Latitude/Longitude	
				Start	End
Item	DWR UCIP Field Study			38.358131 °	38.358131 °
				-121.527540 °	-121.527540 °
DWR ID					
Comment Code					
Inspector Comment					
FS_ID:19848 DS_ID:22404 EP_NO: N/A Repair Type: Non-Urgent Crossing Status: Found UCIP Comments: - needs proper abandonment. FIELD_STRUCT_DESC: *ABANDONED* 4-inch steel pipe on landward slope. 1-inch steel conduit on waterward slope found. FS Date: 8/30/2013

WS view: abandoned 1-inch conduit on levee slope.

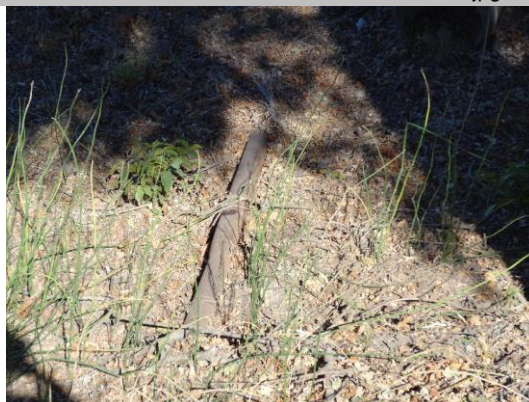
Photo 3 of 3 : UCIP_SP_2017_19848_33732.jpg

LM Start	3.51	Rating **	M	Issue No.	1002 (cont)	
LM End	3.51	Issue Type +	En	Location *	LS	
Category	Supplemental			GPS Latitude/Longitude		
				Start	End	
Item	DWR UCIP Field Study			38.358131 °	38.358131 °	
				-121.527540 °	-121.527540 °	
DWR ID						
Comment Code						
Inspector Comment						
FS_ID:19848 DS_ID:22404 EP_NO: N/A Repair Type: Non-Urgent Crossing Status: Found UCIP Comments: - needs proper abandonment. FIELD_STRUCT_DESC: *ABANDONED* 4-inch steel pipe on landward slope. 1-inch steel conduit on waterward slope found. FS Date: 8/30/2013

LS view: abandoned 4-inch steel pipe on levee slope.

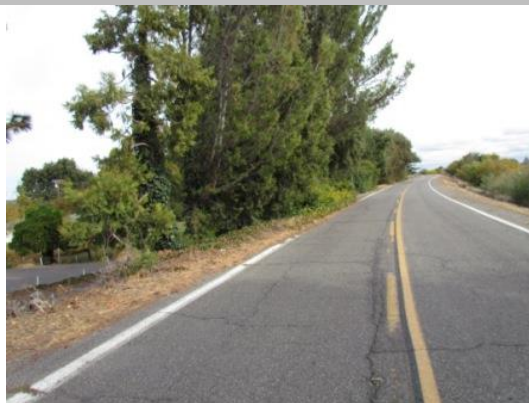
Photo 1 of 1 : SP_2017_RD0150_16_82_20170327_00045.jpg

LM Start	3.54	Rating **	U	Issue No.	82
LM End	3.67	Issue Type +	En	Location *	LS
Category	Earthen Levee			GPS Latitude/Longitude	
				Start	End
Item	Vegetation			38.358565 °	38.359729 °
				-121.527153 °	-121.525345 °
DWR ID	DWR_RD0150_02_s_2012_82				
Comment Code					
V6 : Landscaping					
Inspector Comment

Landscaping was blocking the visibility on the landside of the levee looking upstream.

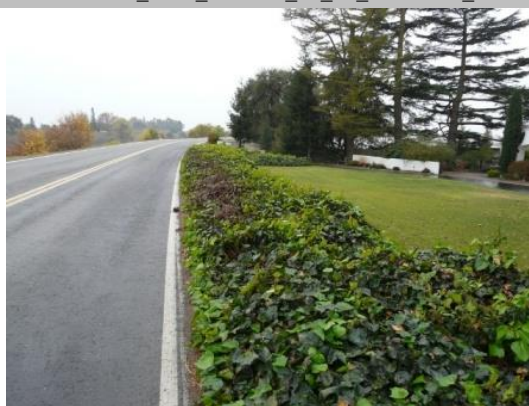
Photo 1 of 1 : SP_2017_RD0150_16_80_20170327_00044.jpg

LM Start	3.84	Rating **	U	Issue No.	80
LM End	3.86	Issue Type +	En	Location *	LS
Category	Earthen Levee			GPS Latitude/Longitude	
				Start	End
Item	Vegetation			38.361419 °	38.361752 °
				-121.523225 °	-121.522974 °
DWR ID	DWR_RD0150_02_s_2012_80				
Comment Code					
V6 : Landscaping					
Inspector Comment

Landscaping in front of a residence on landside of levee from LM 3.90 to LM 3.93. The levee in this location is greater than 100' wide.

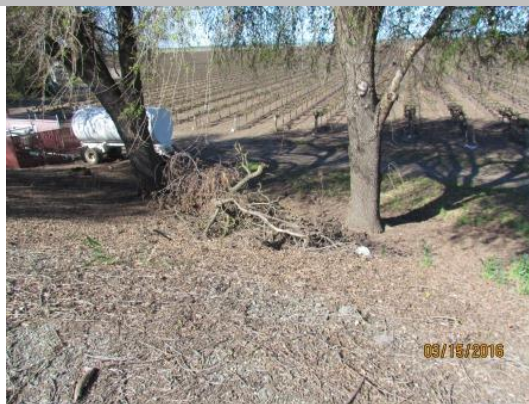
Photo 1 of 1 : SP_2017_RD0150_16_61_20170327_00035.jpg

LM Start	3.91	Rating **	M	Issue No.	61
LM End	3.91	Issue Type +	Ma	Location *	LS
Category	Earthen Levee			GPS Latitude/Longitude	
				Start	End
Item	Encroachments			38.362357 °	38.362357 °
				-121.522582 °	-121.522582 °
DWR ID	DWR_RD0150_02_s_2016_61				
Comment Code					
PR : Prunings					
Inspector Comment

View of prunings on the landside of the levee.

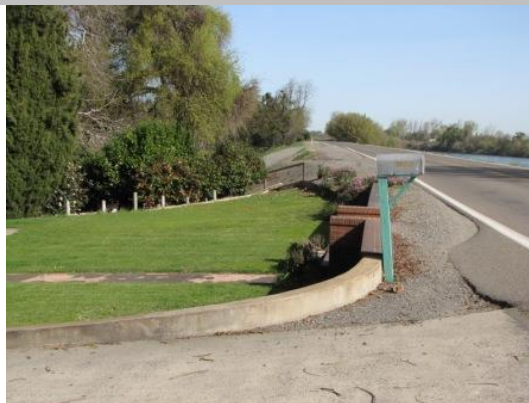
Photo 1 of 1 : SP_2017_RD0150_16_20_20170327_00013.jpg

LM Start	4.08	Rating **	M	Issue No.	20
LM End	4.10	Issue Type +	En	Location *	LS
Category	Earthen Levee			GPS Latitude/Longitude	
				Start	End
Item	Encroachments			38.364854 °	38.365104 °
				-121.522378 °	-121.522365 °
DWR ID	DWR_RD0150_02_s_2012_20				
Comment Code					
BU : Building					
Inspector Comment					
3' retaining wall at the landward shoulder.

View of a retaining wall on the landward slope looking upstream.

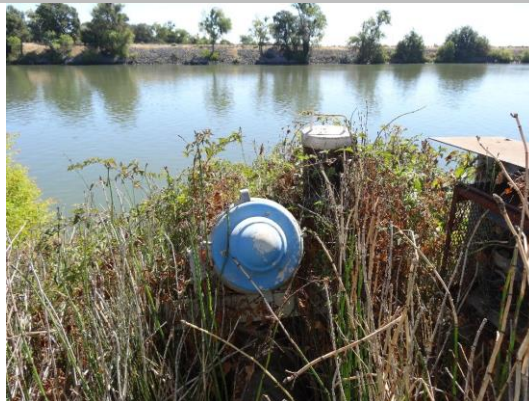
Photo 1 of 3 : UCIP_SP_2017_42702_33782.jpg

Comment Code					
Inspector Comment					
FS_ID:42702 DS_ID:22407 EP_NO: 13505 Repair Type: Non-Urgent Crossing Status: Found UCIP Comments: Appears abandoned and if so should be done so properly.- no pipe and structure found on landside.- siphon breaker in 24" CMP riser on waterside.- control box and electric conduit on waterside slope. FIELD_STRUCT_DESC: 14-inch steel pipe through the levee, 5.0 feet below the crown; slanted pump on the waterside slope. Siphon breaker in the waterside slope in corrugated metal pipe riser. A control box and electric conduit on waterside slope. (Permit No. 13505 - Clara Herringer). O&M Manual SAC 112, March 1957. FS Date: 8/30/2013

LM Start	4.17	Rating **	M	Issue No.	1003 (cont)
LM End	4.17	Issue Type +	En	Location *	LS

WS view: slanted pump on levee slope.

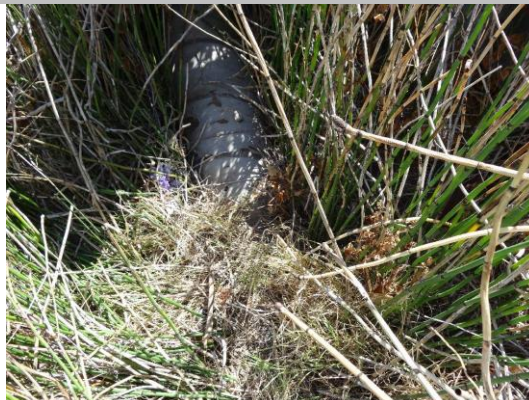
Photo 2 of 3 : UCIP_SP_2017_42702_33781.jpg

WS view: exposed 14-inch steel pipe on levee slope.

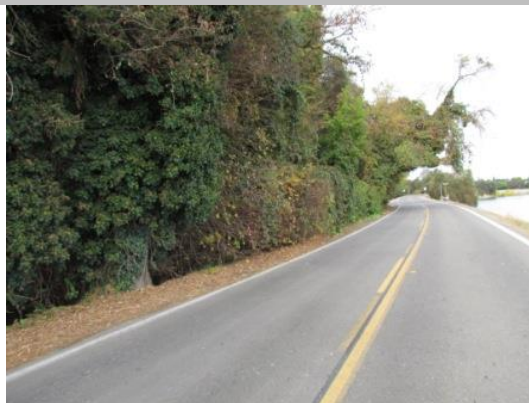
Photo 1 of 1 : SP_2017_RD0150_16_76_20170327_00042.jpg

LM Start	4.70	Rating **	U	Issue No.	76
LM End	4.72	Issue Type +	En	Location *	LS
Category	Earthen Levee			GPS Latitude/Longitude	
				Start	End
Item	Vegetation			38.373688 °	38.373970 °
				-121.524280 °	-121.524403 °
DWR ID	DWR_RD0150_02_s_2012_76				
Comment Code					
V6 : Landscaping					
Inspector Comment

Trees were obstructing the view of the landside slope of the levee looking upstream.

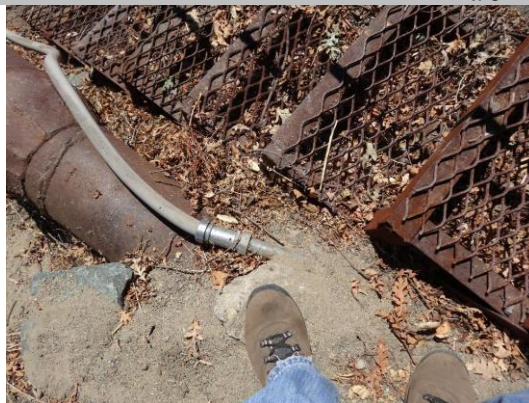
Photo 3 of 3 : UCIP_SP_2017_20740_34939.jpg

LM Start	5.24	Rating **	M	Issue No.	1004 (cont)	
LM End	5.24	Issue Type +	En	Location *	LS	
Category	Supplemental			GPS Latitude/Longitude		
				Start		End
Item	DWR UCIP Field Study			38.381079 °		38.381079 °
				-121.524166 °		-121.524166 °
DWR ID						
Comment Code						
Inspector Comment						
FS_ID:20740 DS_ID:22410 EP_NO: N/A Repair Type: Non-Urgent Crossing Status: Found UCIP Comments: - 2" electric conduit and gate valve on WS.- abandoned old pump not removed from WS- working during field survey FIELD_STRUCT_DESC: 12-inch pipe and 2-inch electric conduit through the levee, 3.0 feet below the crown. Service pole and standpipe at the toe of the landward slope. (C. Sakai) O&M Manual SAC 112, March 1957. FS Date: 8/30/2013

WS view: steel steps to pump platform, exposed steel pipe, and electric conduit on levee slope.

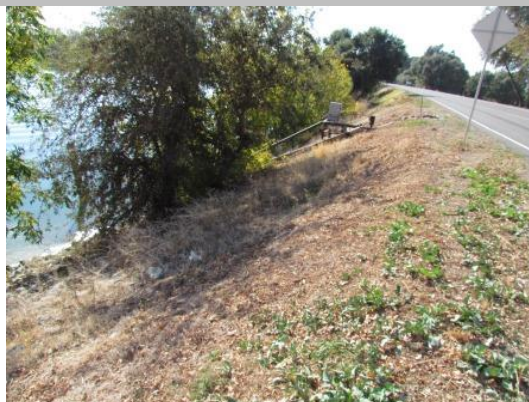
Photo 1 of 2 : SP_2017_RD0150_16_975_20170327_00056.jpg

LM Start	5.24	Rating **	M	Issue No.	975
LM End	5.24	Issue Type +	Ma	Location *	WS
Category	Earthen Levee			GPS Latitude/Longitude	
				Start	End
Item	Slope Stability			38.381126 °	38.381126 °
				-121.524207 °	-121.524207 °
DWR ID	DWR_RD0150_02_s_2013_975				
Comment Code					
S1 : Repair slope instability.					
Inspector Comment					
Depression in the waterward slope at the shoulder over an irrigation pipe.

View of minor slope instability on the waterside slope of the levee looking downstream during fall 2013 inspection.

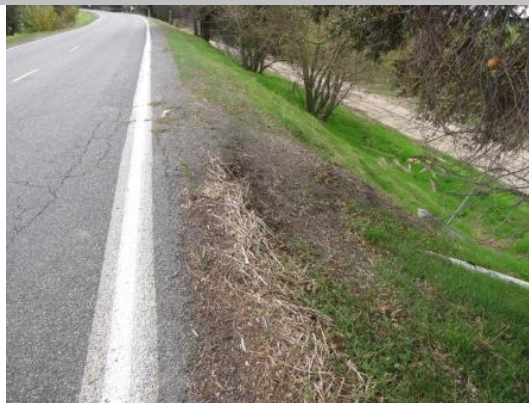
Photo 2 of 2 : SP_2017_RD0150_16_975_20170327_00057.jpg

LM Start	5.24	Rating **	M	Issue No.	975 (cont)	
LM End	5.24	Issue Type +	Ma	Location *	WS	
Category	Earthen Levee			GPS Latitude/Longitude		
				Start	End	
Item	Slope Stability			38.381126 °	38.381126 °	
				-121.524207 °	-121.524207 °	
DWR ID	DWR_RD0150_02_s_2013_975					
Comment Code						
S1 : Repair slope instability.						
Inspector Comment						
Depression in the waterward slope at the shoulder over an irrigation pipe.

View of a minor depression along the landward slope of the levee over a pipe penetration looking downstream.

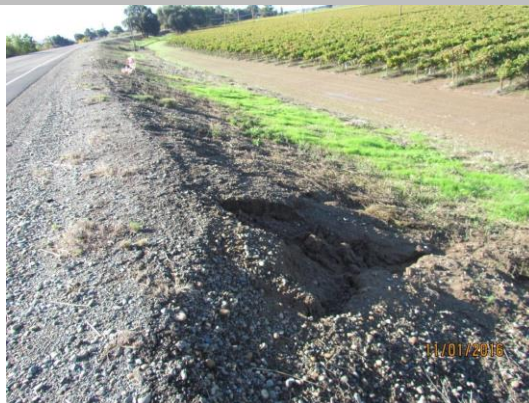
Photo 2 of 2 : SP_2017_RD0150_16_52_20170327_00026.jpg

LM Start	5.90	Rating **	M	Issue No.	52 (cont)	
LM End	5.90	Issue Type +	Ma	Location *	LS	
Category	Earthen Levee			GPS Latitude/Longitude		
				Start		End
Item	Erosion / Bank Caving			38.387915 °	38.387915 °	
				-121.516002 °	-121.516002 °	
DWR ID	DWR_RD0150_02_f_2016_52					
Comment Code						
E2 : Schedule repair of erosion site prior to the next inspection.						
Inspector Comment						
Erosion due to runoff.

View of an erosion due to runoff on the landside of the levee. Fall 2016

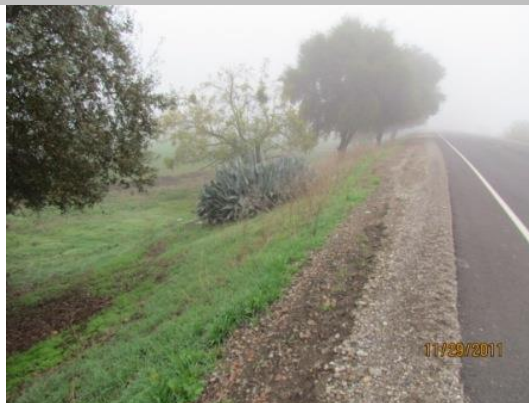
Photo 1 of 1 : SP_2017_RD0150_16_27_20170327_00015.jpg

LM Start	6.30	Rating **	M	Issue No.	27
LM End	6.30	Issue Type +	En	Location *	LS
Category	Earthen Levee			GPS Latitude/Longitude	
				Start	End
Item	Vegetation			38.393655 °	38.393655 °
				-121.514654 °	-121.514654 °
DWR ID	DWR_RD0150_02_s_2012_27				
Comment Code					
V6 : Landscaping					
Inspector Comment					
Century plant on the landward slope.

Century plant was found on the landside of the levee looking upstream.

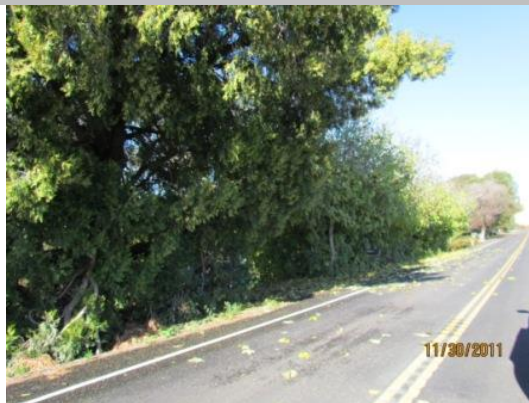
Photo 1 of 1 : SP_2017_RD0150_16_31_20170327_00018.jpg

LM Start	6.36	Rating **	U	Issue No.	31
LM End	6.36	Issue Type +	En	Location *	LS
Category	Earthen Levee			GPS Latitude/Longitude	
				Start	End
Item	Vegetation			38.394416 °	38.394416 °
				-121.514590 °	-121.514590 °
DWR ID	DWR_RD0150_02_s_2012_31				
Comment Code					
V6 : Landscaping					
Inspector Comment

Trees need to be trimmed on the landside of the levee looking upstream.

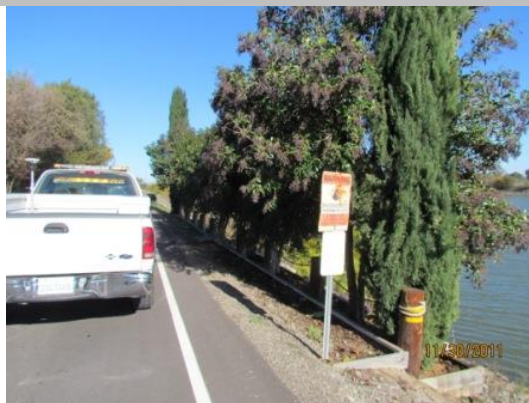
Photo 1 of 1 : SP_2017_RD0150_16_34_20170327_00020.jpg

LM Start	6.42	Rating **	M	Issue No.	34
LM End	6.42	Issue Type +	En	Location *	WS
Category	Earthen Levee			GPS Latitude/Longitude	
				Start	End
Item	Vegetation			38.395340 °	38.395340 °
				-121.514528 °	-121.514528 °
DWR ID	DWR_RD0150_02_s_2012_34				
Comment Code					
V6 : Landscaping					
Inspector Comment

Landscaping was found on the waterside of the levee looking upstream.

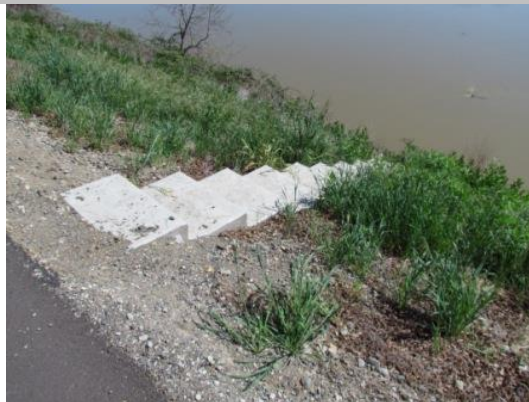
Photo 1 of 1 : SP_2017_RD0150_16_42_20170327_00021.jpg

LM Start	6.48	Rating **	M	Issue No.	42
LM End	6.48	Issue Type +	En	Location *	WS
Category	Earthen Levee			GPS Latitude/Longitude	
				Start	End
Item	Encroachments			38.396235 °	38.396235 °
				-121.514547 °	-121.514547 °
DWR ID	DWR_RD0150_02_s_2012_42				
Comment Code					
ST : Stairway					
Inspector Comment					
Unpermitted stairway.

A stairway was found on the waterside slope of the levee looking upstream.

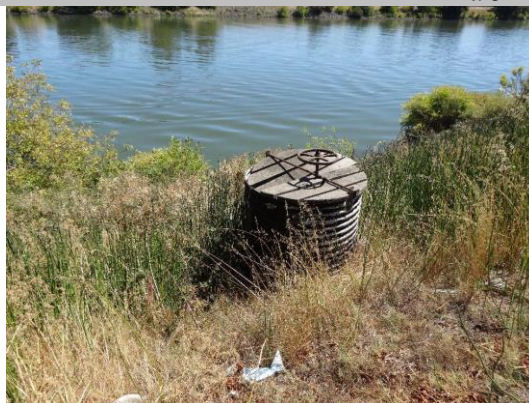
Photo 1 of 2 : UCIP_SP_2017_41720_34081.jpg

LM Start	6.57	Rating **	M	Issue No.	1007
LM End	6.57	Issue Type +	En	Location *	LS
Category	Supplemental			GPS Latitude/Longitude	
				Start	End
Item	DWR UCIP Field Study			38.397451 °	38.397451 °
				-121.514601 °	-121.514601 °
DWR ID					
Comment Code					
Inspector Comment					
FS_ID:41720					
DS_ID:22425					
EP_NO: N/A					
Repair Type: Non-Urgent					
Crossing Status: Found					
UCIP Comments: Need to clear dense vegetation on WS.- water					
filtration plant on LS levee toe.- Slide gate on CMP riser on WS.					
FIELD_STRUCT_DESC: 8-inch pipe through the levee, 12.0 feet below					
the crown, gate valve in CM riser on the waterward slope. Pump at the					
landward toe. (Joe Gomez)					
FS Date: 8/30/2013

WS view: CMP riser with gate valve on levee slope. Dense vegetation on levee slope and stream bank.

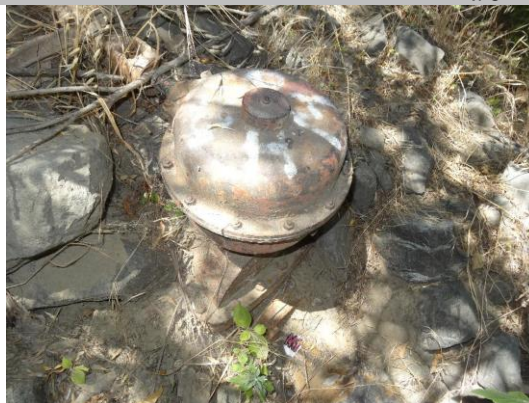
Photo 2 of 3 : UCIP_SP_2017_41646_34101.jpg

LM Start	6.69	Rating **	M	Issue No.	1008 (cont)
LM End	6.69	Issue Type +	En	Location *	LS
Category	Supplemental			GPS Latitude/Longitude	
				Start	End
Item	DWR UCIP Field Study			38.399167 °	38.399167 °
				-121.514793 °	-121.514793 °
DWR ID					
Comment Code					
Inspector Comment					
FS_ID:41646					
DS_ID:22426					
EP_NO: N/A					
Repair Type: Non-Urgent					
Crossing Status: Found					
UCIP Comments: - abandoned very old gate valve also found on WS.					
Rest of pipe should be evaluated due to its age.					
FIELD_STRUCT_DESC: 9-inch steel irrigation pipe 9.7 feet below the crown, gate valve and pump house on the landside (LS). (Permit No. 8551, 1973 - Souza). O&M Manual SAC 112, March 1957.					
FS Date: 8/30/2013

WS view: An abandoned old gate valve on inlet steel pipe on stream bank.

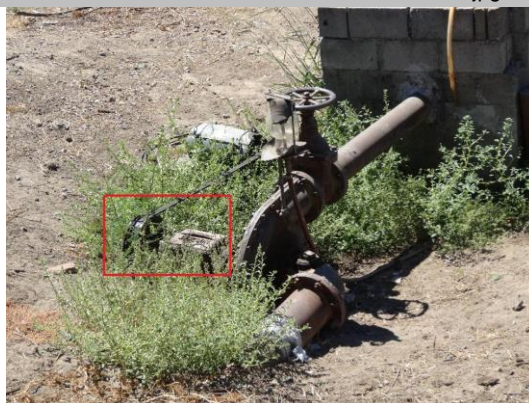
Photo 3 of 3 : UCIP_SP_2017_41646_34100.jpg

LS view: concrete masonry distribution box (top), steel pipe, gate valve, air vent, and pump (left) on levee toe.

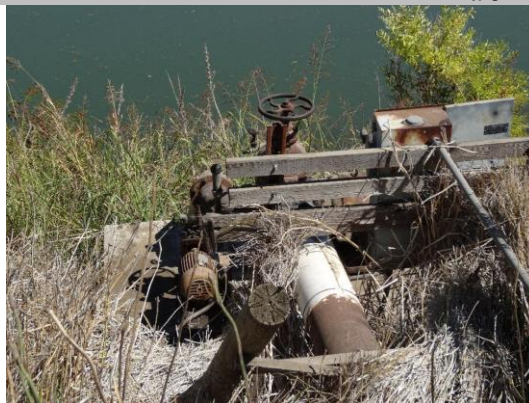
Photo 1 of 3 : UCIP_SP_2017_50387_35002.jpg

LM Start	6.80	Rating **	U	Issue No.	1009
LM End	6.80	Issue Type +	En	Location *	LS
Category	Supplemental			GPS Latitude/Longitude	
				Start	End
Item	DWR UCIP Field Study			38.400835 °	38.400835 °
				-121.515066 °	-121.515066 °
DWR ID					
Comment Code					
Inspector Comment					
FS_ID:50387 DS_ID:22427 EP_NO: 1703 Repair Type: Urgent Crossing Status: Found UCIP Comments: - significant erosion along pipe alignment on LS slope.- pump on concrete pad- service pole on LS slope. FIELD_STRUCT_DESC: 12-inch steel pipe through the levee, 4.5 feet below the crown, pump and gate valve on the waterward slope. Service pole and standpipe on the landward shoulder. (App. No. 1703 - M. Silva). Landowner is Craig Silva 916-396-4651, 916-876-6362. Jim Pileman (leasing land and farming it) FS Date: 8/30/2013

WS view: steel pipe, electric conduit, gate valve, and pump on levee slope.

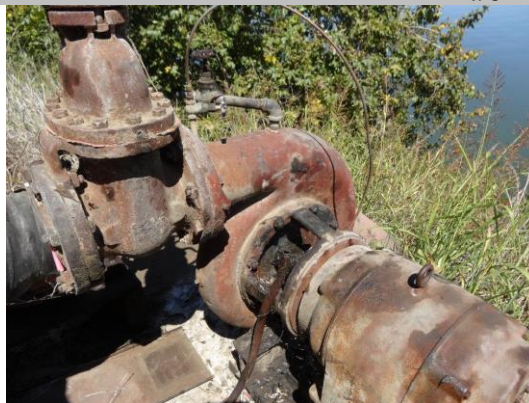
Photo 3 of 3 : UCIP_SP_2017_50387_35000.jpg

LM Start	6.80	Rating **	U	Issue No.	1009 (cont)	
LM End	6.80	Issue Type +	En	Location *	LS	
Category	Supplemental			GPS Latitude/Longitude		
				Start		End
Item	DWR UCIP Field Study			38.400835 °		38.400835 °
				-121.515066 °		-121.515066 °
DWR ID						
Comment Code						
Inspector Comment						
FS_ID:50387 DS_ID:22427 EP_NO: 1703 Repair Type: Urgent Crossing Status: Found UCIP Comments: - significant erosion along pipe alignment on LS slope.- pump on concrete pad- service pole on LS slope. FIELD_STRUCT_DESC: 12-inch steel pipe through the levee, 4.5 feet below the crown, pump and gate valve on the waterward slope. Service pole and standpipe on the landward shoulder. (App. No. 1703 - M. Silva). Landowner is Craig Silva 916-396-4651, 916-876-6362. Jim Pileman (leasing land and farming it) FS Date: 8/30/2013

WS view: closer view of gate valve and pump on levee slope

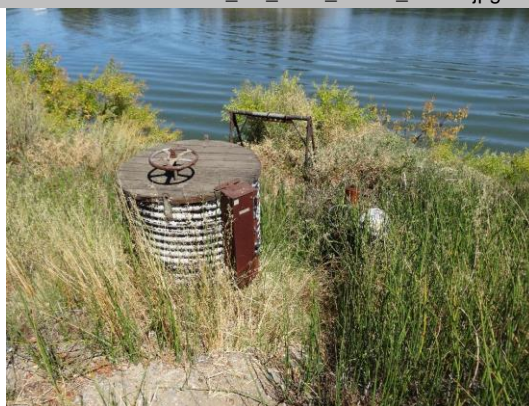
Photo 1 of 3 : UCIP_SP_2017_50386_34162.jpg

LM Start	7.00	Rating **	U	Issue No.	1010
LM End	7.00	Issue Type +	En	Location *	LS
Category	Supplemental			GPS Latitude/Longitude	
				Start	End
Item	DWR UCIP Field Study			38.403513 °	38.403513 °
				-121.516162 °	-121.516162 °
DWR ID					
Comment Code					
Inspector Comment					
FS_ID:50386 DS_ID:22429 EP_NO: N/A Repair Type: Urgent Crossing Status: Found UCIP Comments: - soil erosion along pipe alignment on LS slope.- needs more investigation and mitigation for soil erosion. FIELD_STRUCT_DESC: 8-inch steel pipe through the levee 10.0 feet below the crown, pump on concrete slab and slide gate in CMP riser on the waterward slope. Pipe through the levee section encased in reinforced concrete. A concrete standpipe on landside toe. (A. Monice). Landowner is Steve Winkler 916-599-1052. FS Date: 8/30/2013

WS view: CMP riser with slide gate and pump (right) on levee slope.

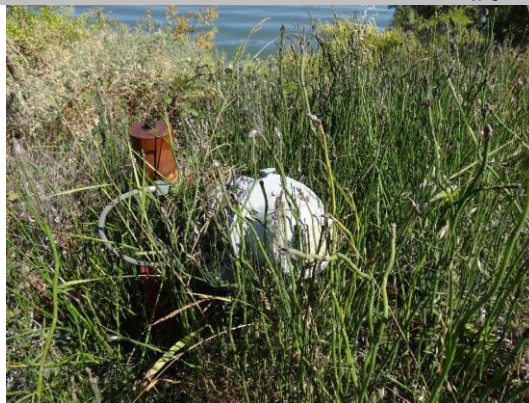
Photo 3 of 3 : UCIP_SP_2017_50386_34160.jpg

LM Start	7.00	Rating **	U	Issue No.	1010 (cont)	
LM End	7.00	Issue Type +	En	Location *	LS	
Category	Supplemental			GPS Latitude/Longitude		
				Start		End
Item	DWR UCIP Field Study			38.403513 °		38.403513 °
				-121.516162 °		-121.516162 °
DWR ID						
Comment Code						
Inspector Comment						
FS_ID:50386 DS_ID:22429 EP_NO: N/A Repair Type: Urgent Crossing Status: Found UCIP Comments: - soil erosion along pipe alignment on LS slope.- needs more investigation and mitigation for soil erosion. FIELD_STRUCT_DESC: 8-inch steel pipe through the levee 10.0 feet below the crown, pump on concrete slab and slide gate in CMP riser on the waterward slope. Pipe through the levee section encased in reinforced concrete. A concrete standpipe on landside toe. (A. Monice). Landowner is Steve Winkler 916-599-1052. FS Date: 8/30/2013

WS view: pump on levee slope. Dense vegetation on levee slope.
